WELL-INTEGRITY SURVEY (PHASE II) OF ABANDONED HOMESTEAD WATER WELLS IN THE HIGH PLAINS AQUIFER, FORMER PANTECH ORDNANCE PLANT AND TEXAS TECH RESEARCH FARM NEAR AMARILLO, TEXAS, 1995

U.S. GEOLOGICAL SURVEY
Open-File Report 95-751

Prepared in cooperation with the
U.S. ARMY CORPS OF ENGINEERS,
TULSA DISTRICT

By Glenn A. Rivers

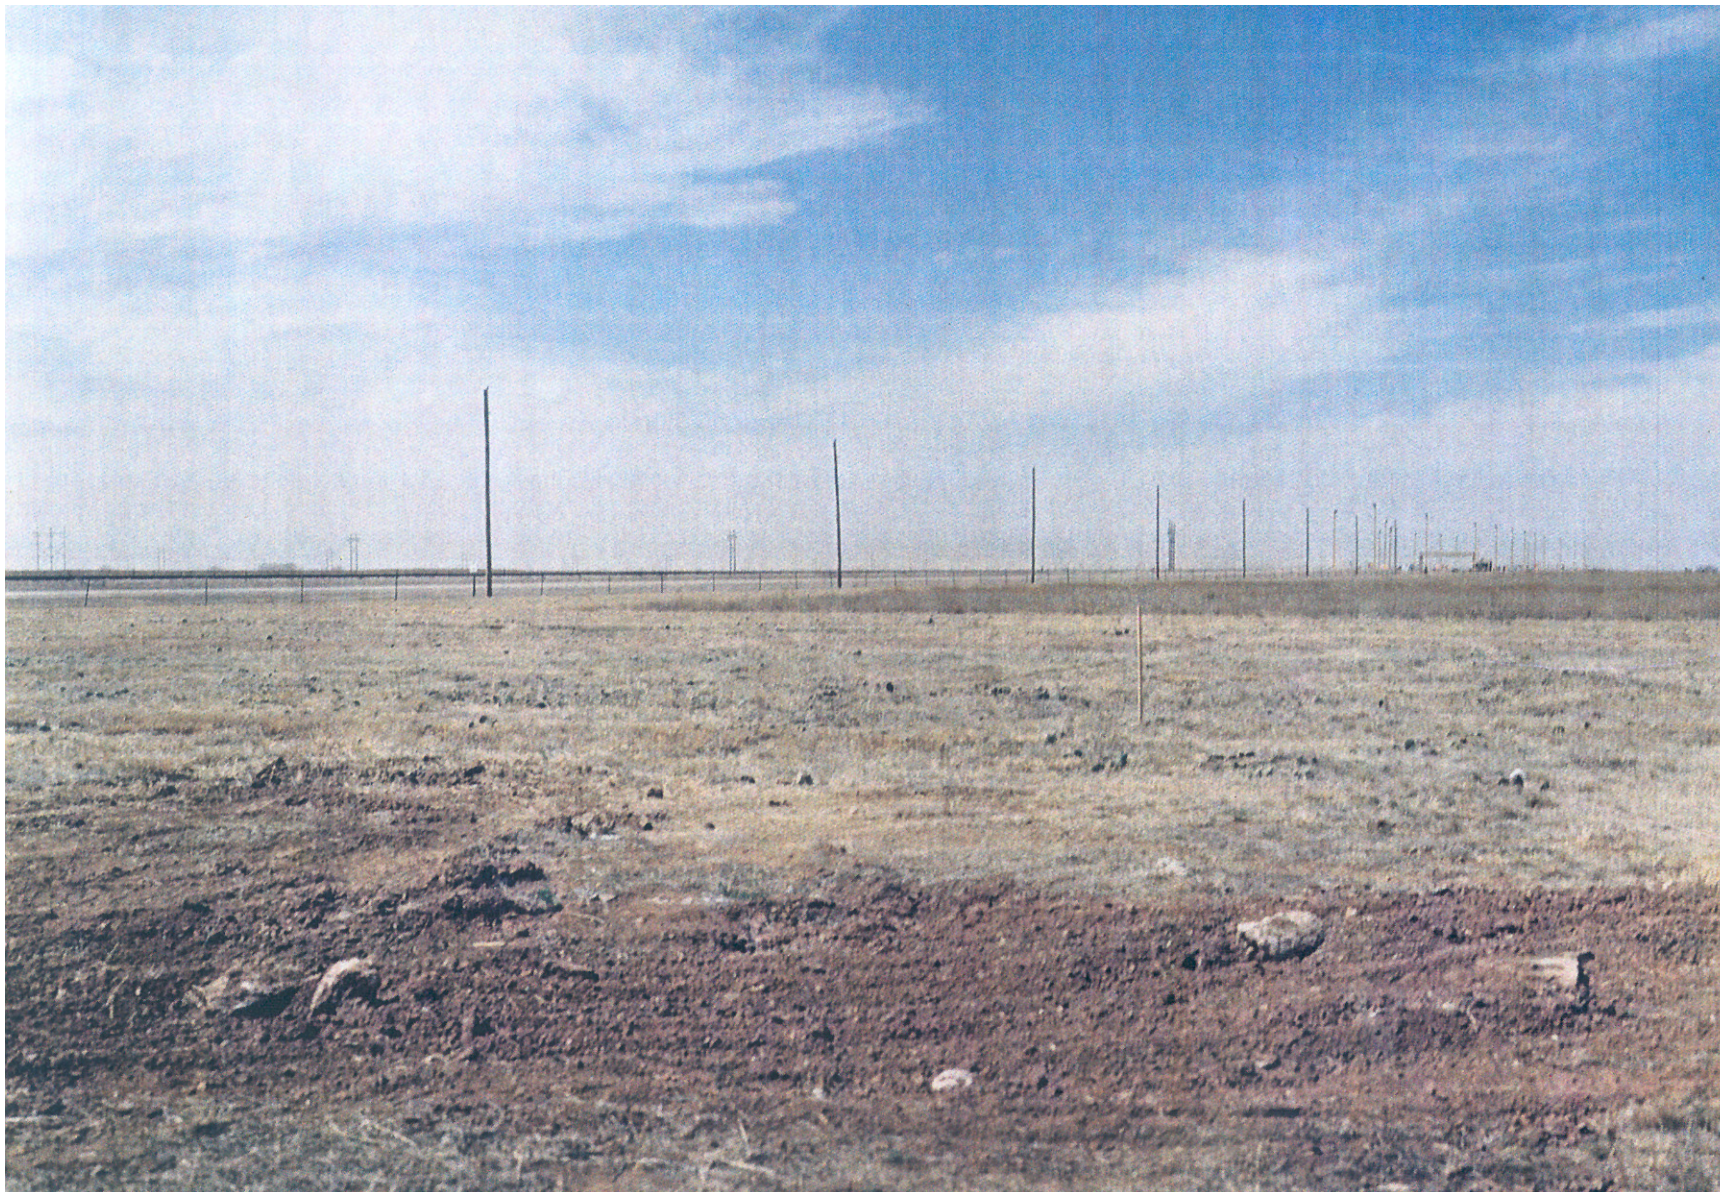
Figure 3-3. Homestead site HL-7 after excavation, former Pantex Ordnance Plant and Texas Tech Research Farm near Amarillo, Texas. Photograph by John S. Ebling.

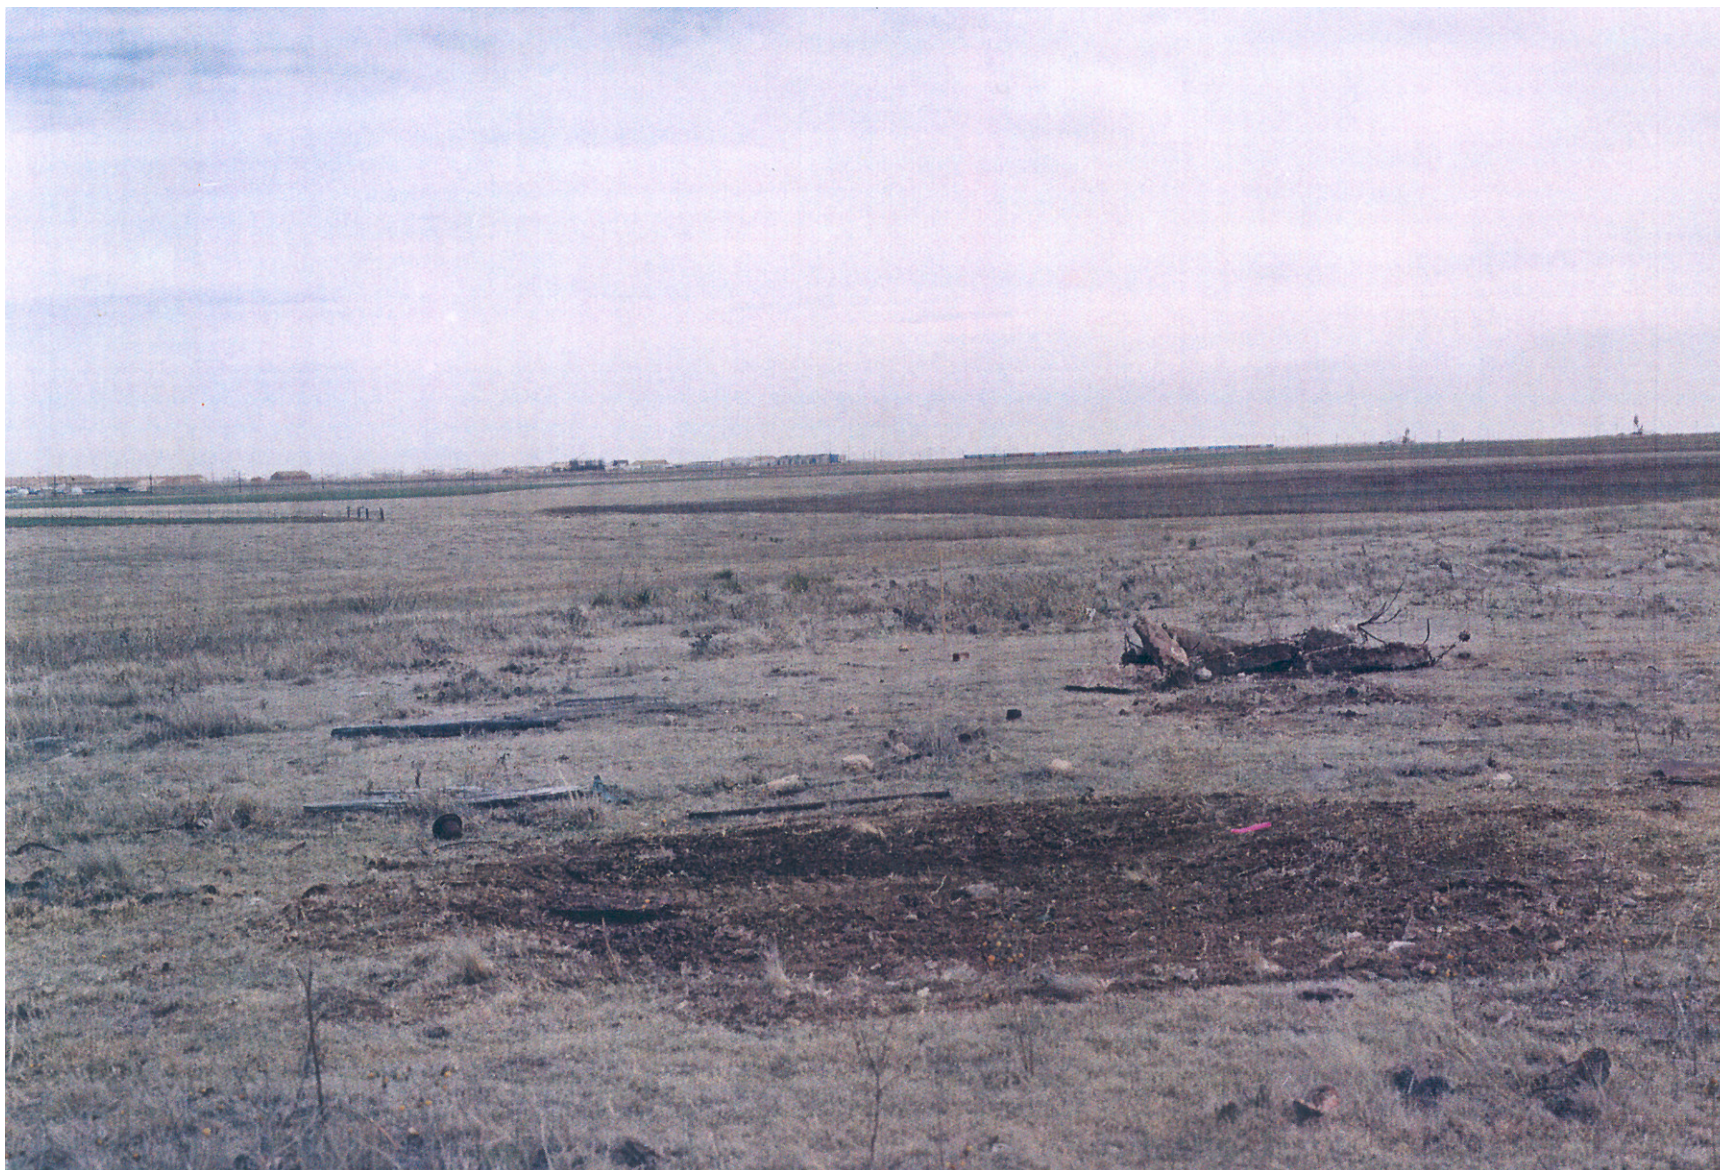
Figure 3-4. Homestead site HL-8 after excavation, former Pantex Ordnance Plant and Texas Tech Research Farm near Amarillo, Texas. Photograph by John S. Ebling.

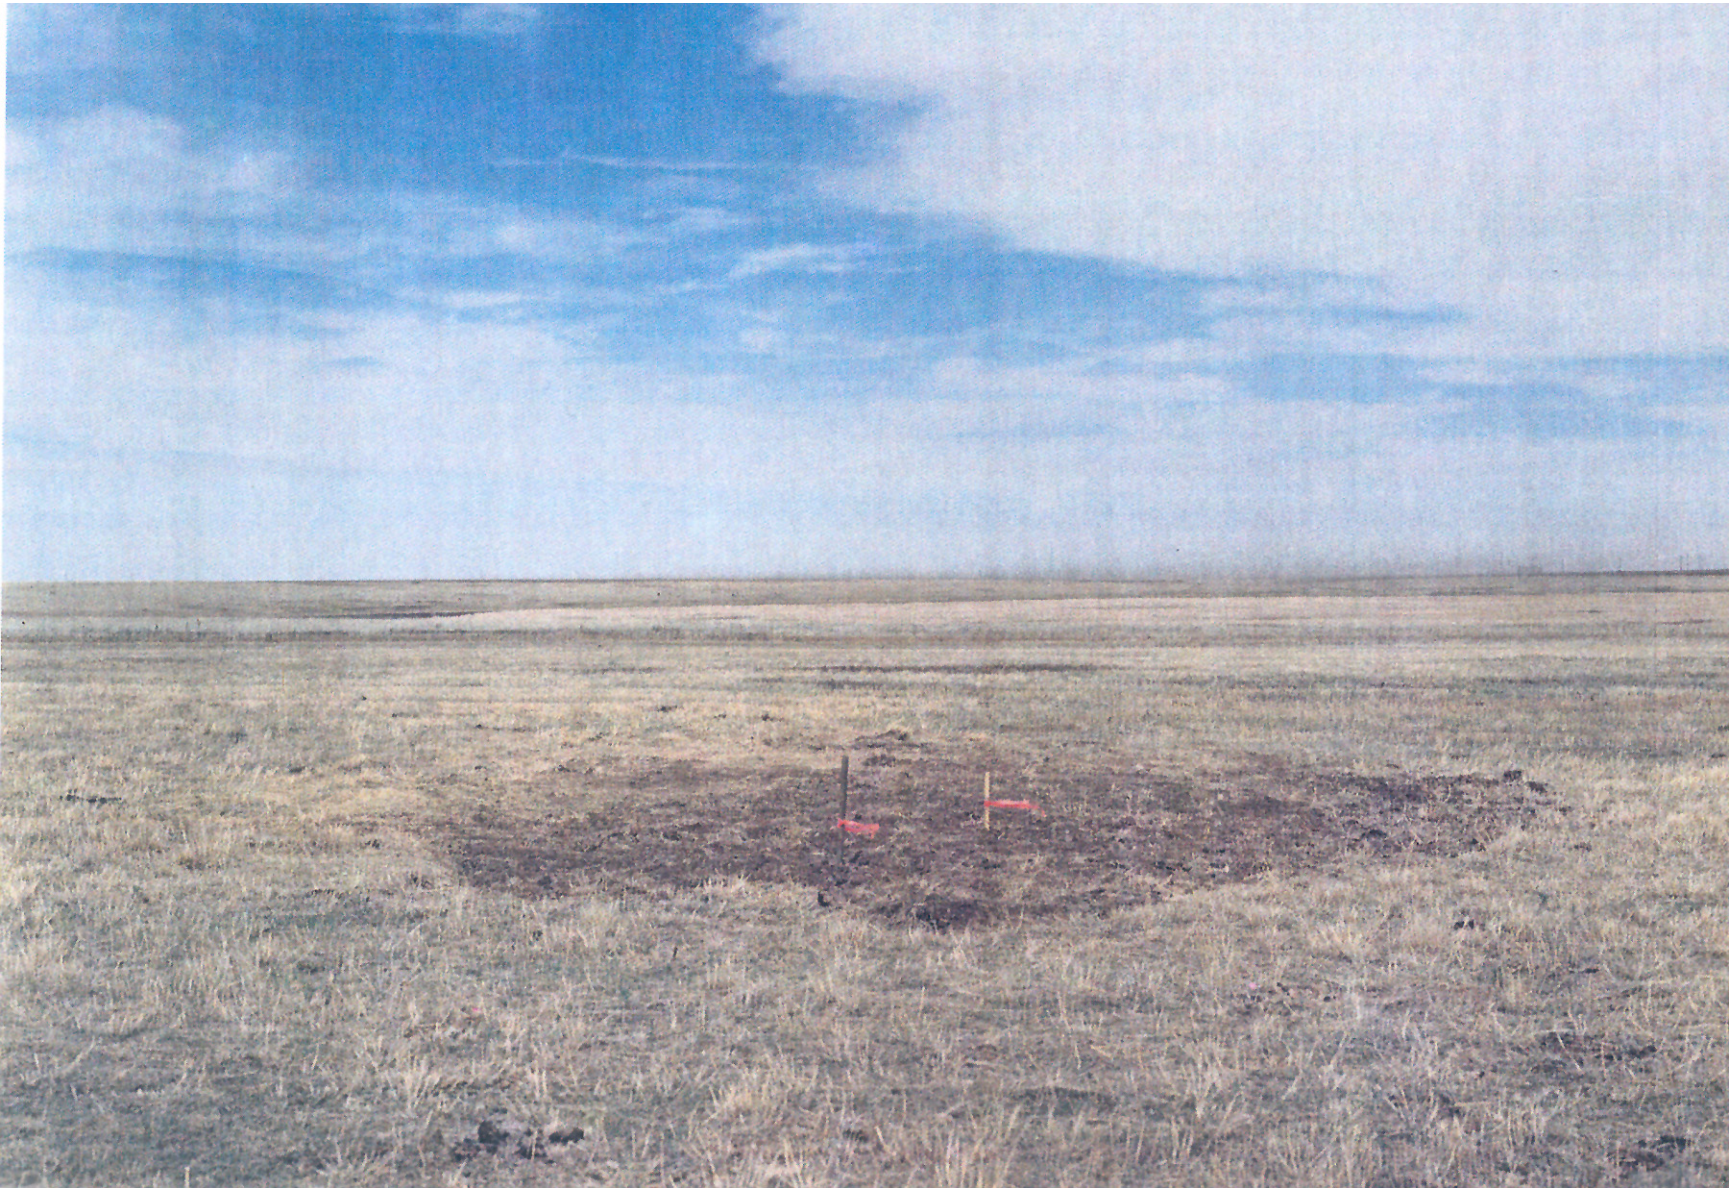
Figure 3-5. Homestead site HL-9 after excavation, former Pantex Ordnance Plant and Texas Tech Research Farm near Amarillo, Texas. Photograph by John S. Ebling.

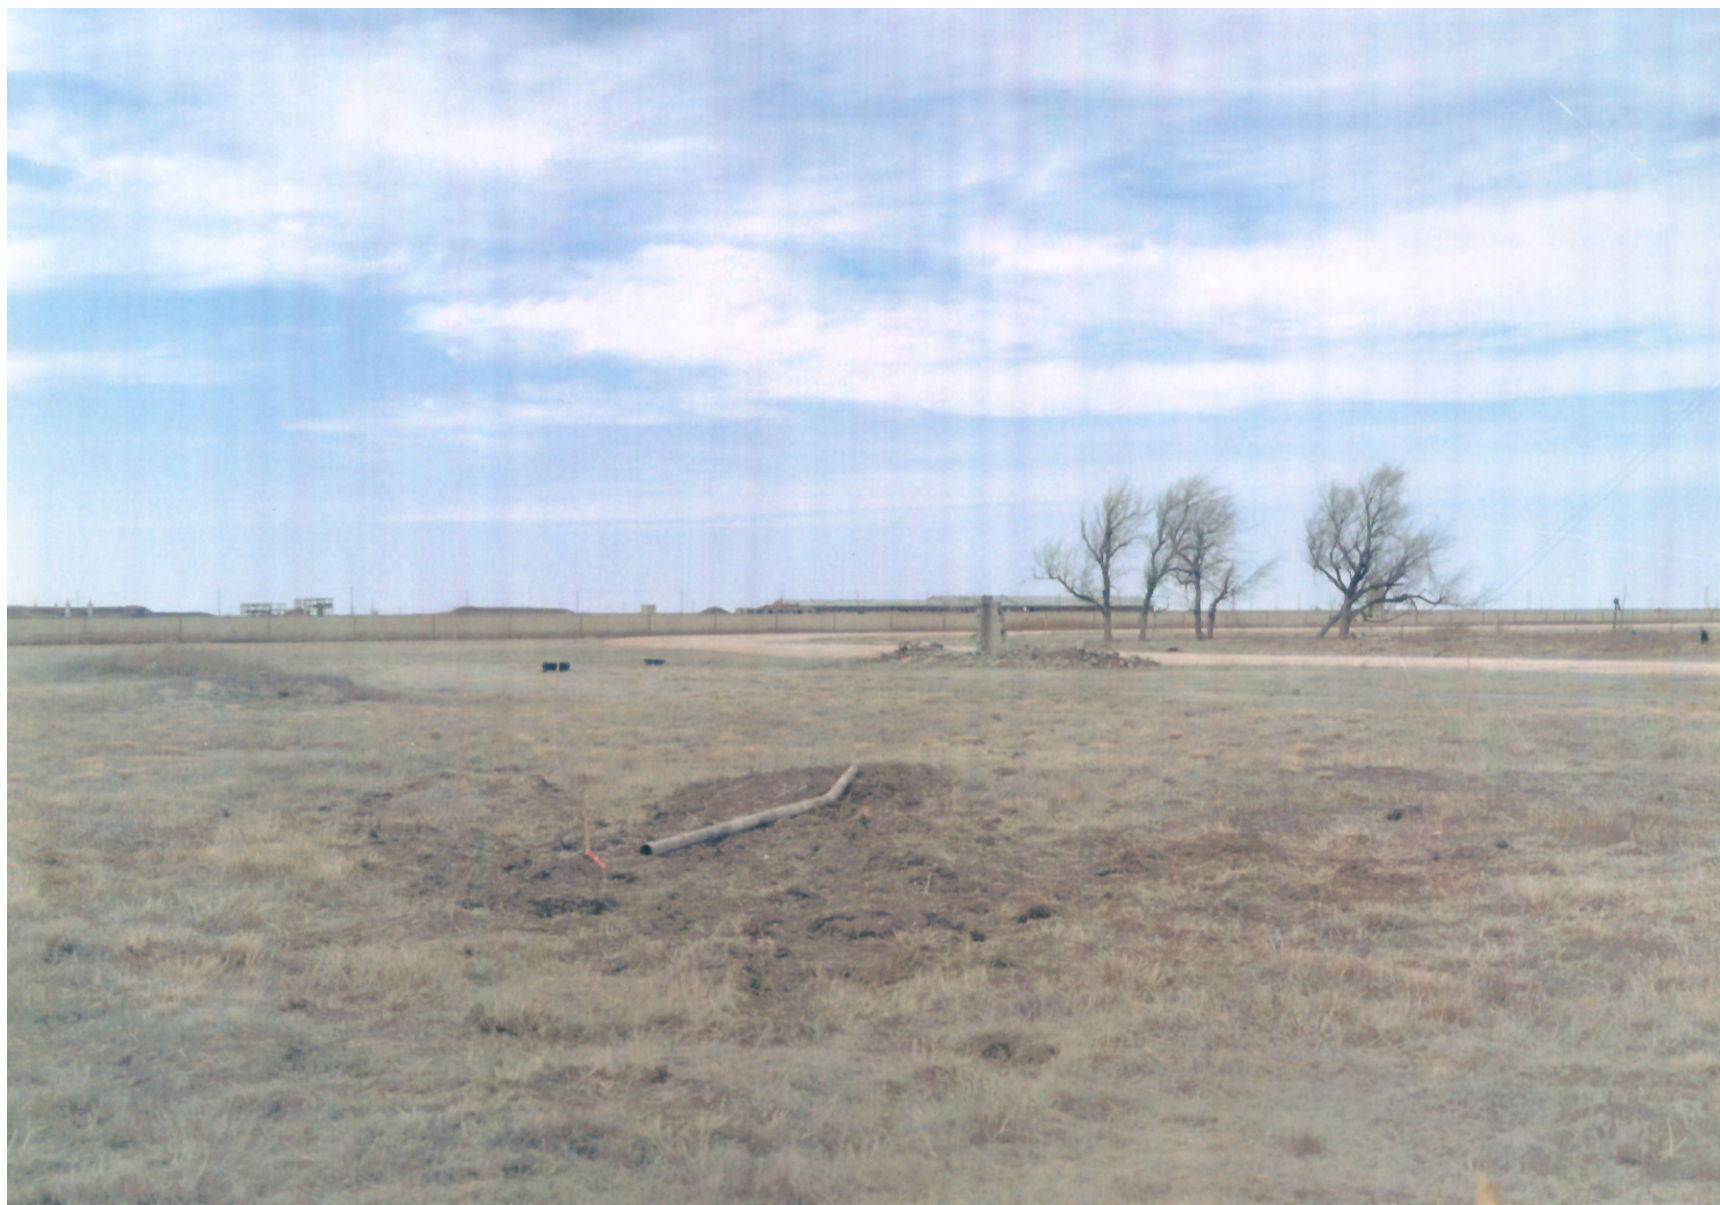
Figure 3-6. Homestead site HL-11 after excavation, former Pantex Ordnance Plant and Texas Tech Research Farm near Amarillo, Texas. Photograph by John S. Ebling.

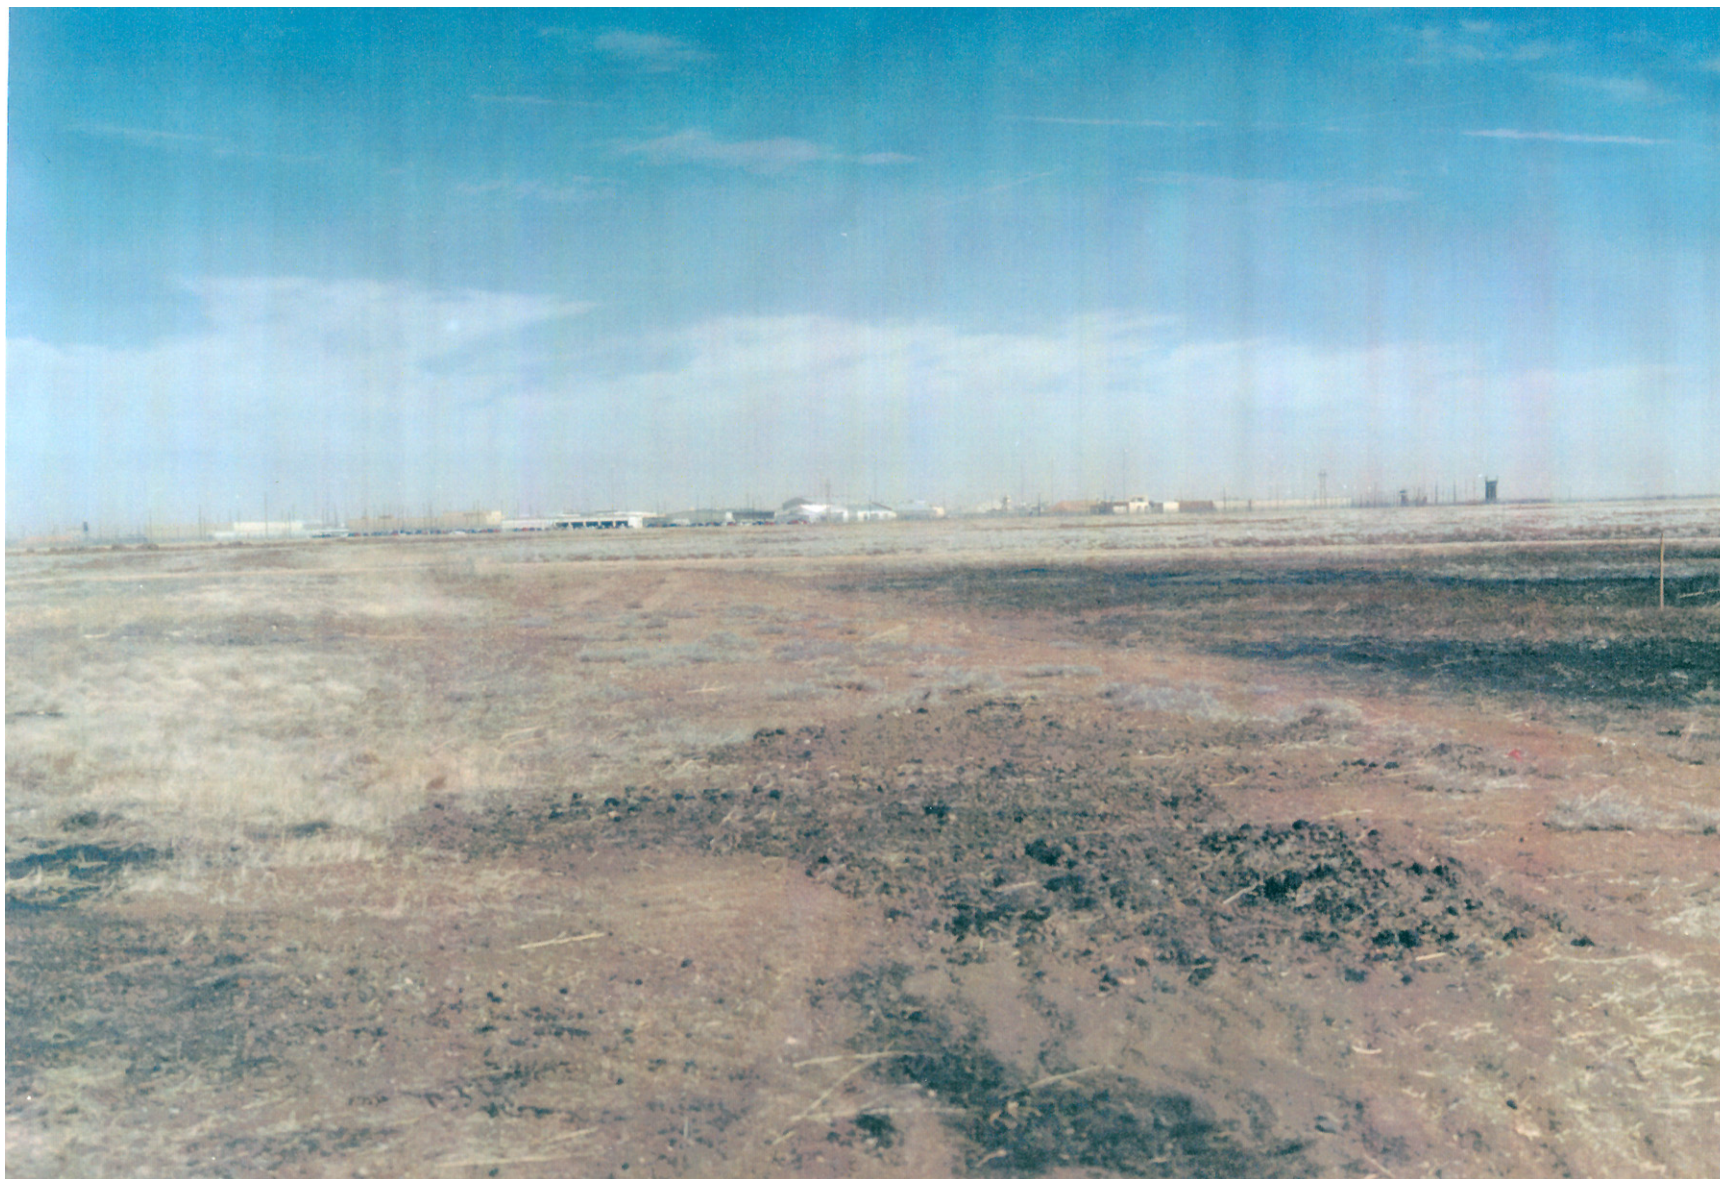
Figure 3-7. Homestead site HL-13 after excavation, former Pantex Ordnance Plant and Texas Tech Research Farm near Amarillo, Texas. Photograph by John S. Ebling.

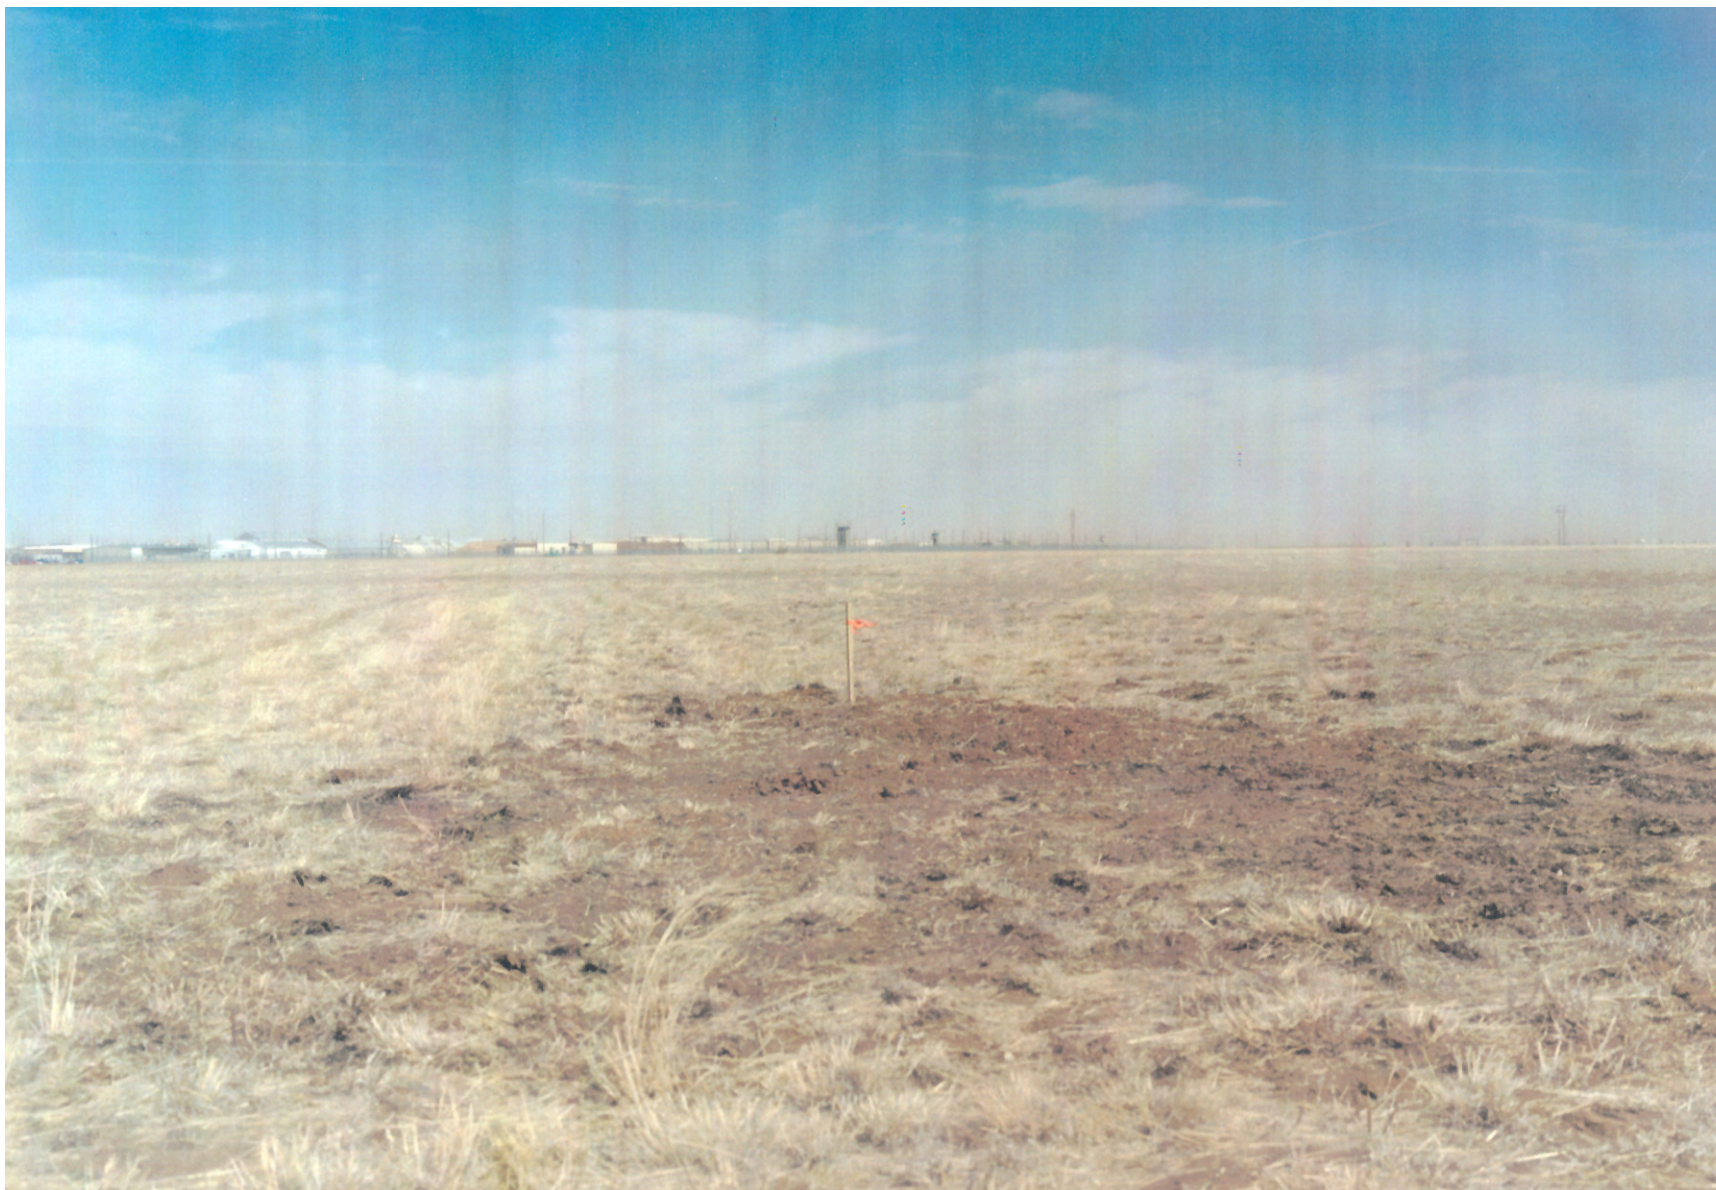
Figure 3-8. Homestead site HL-15 after excavation, former Pantex Ordnance Plant and Texas Tech Research Farm near Amarillo, Texas. Photograph by John S. Ebling.

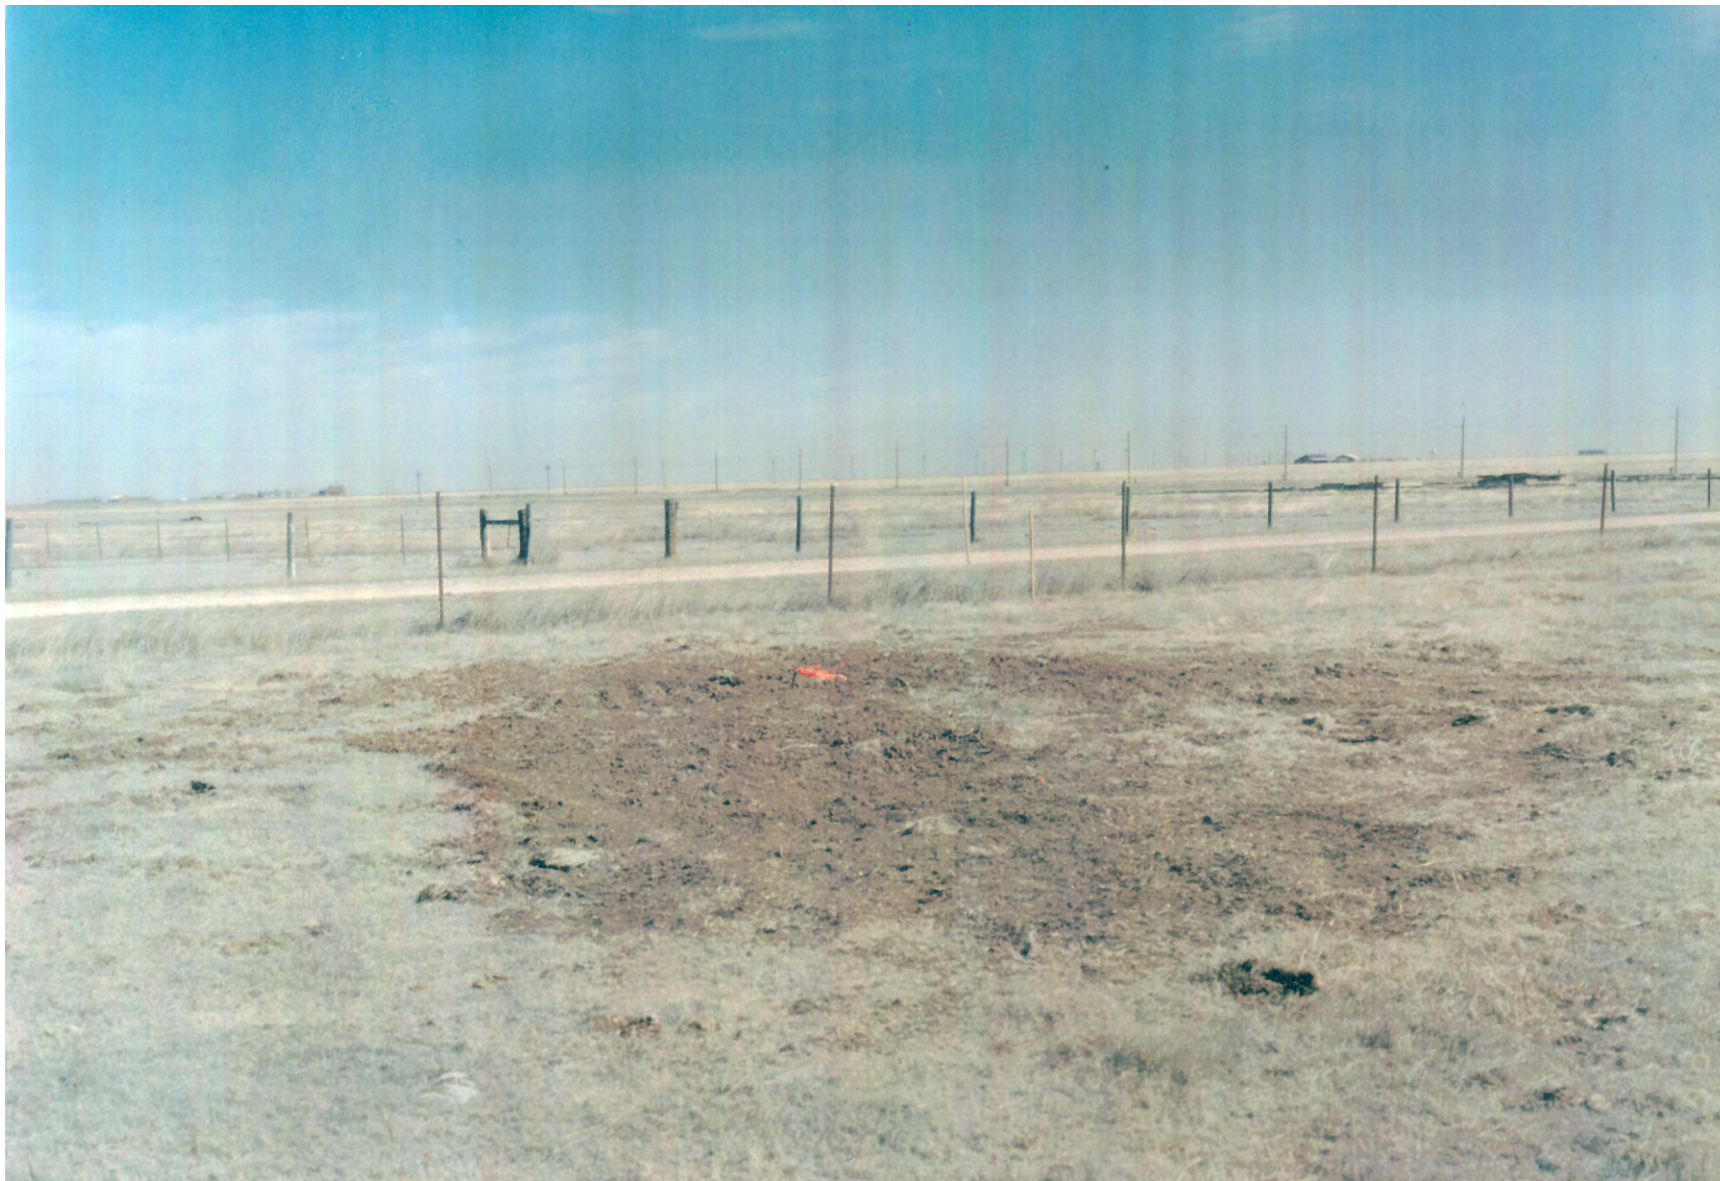
Figure 3-9. Homestead site HL-16 after excavation, former Pantex Ordnance Plant and Texas Tech Research Farm near Amarillo, Texas. Photograph by John S. Ebling.

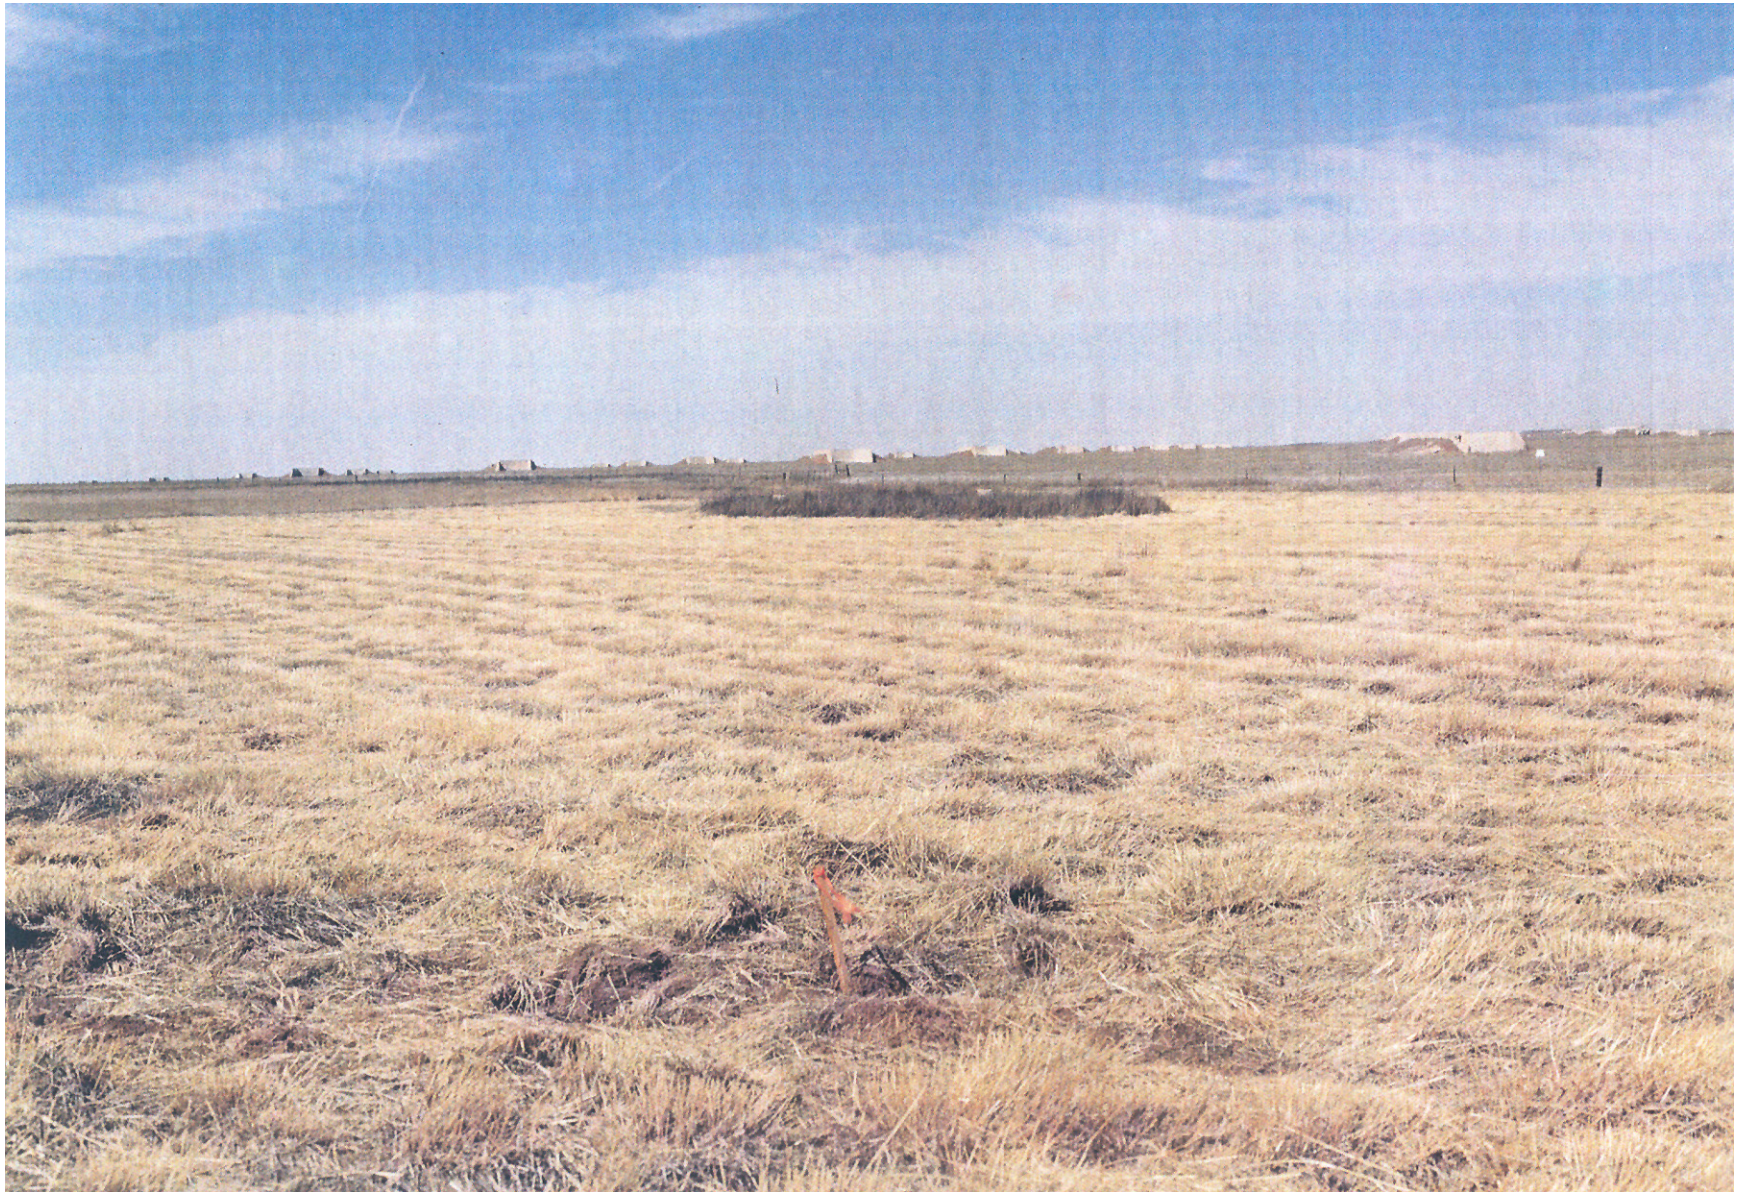
Figure 3-10. Homestead site HL-18 after excavation, former Pantex Ordnance Plant and Texas Tech Research Farm near Amarillo, Texas. Photograph by John S. Ebling.
